U.S ENVIRONMENTAL PROTECTION AGENCY
SUBAREA II FOURTH AVENUE AND GAMBELL STREET REMOVAL ACTION
INDOOR AIR QUALITY QUESTIONNAIRE AND BUILDING INVENTORY

Property address: EA Block 26A Lot 6A; 710 East 3rd Avenue, Anchorage, AK. 99515

SUBAREA II FOURTH AVENUE AND
GAMBELL STREET REMOVAL ACTION
Anchorage, Alaska

710 East 3rd Street
Anchorage, Alaska

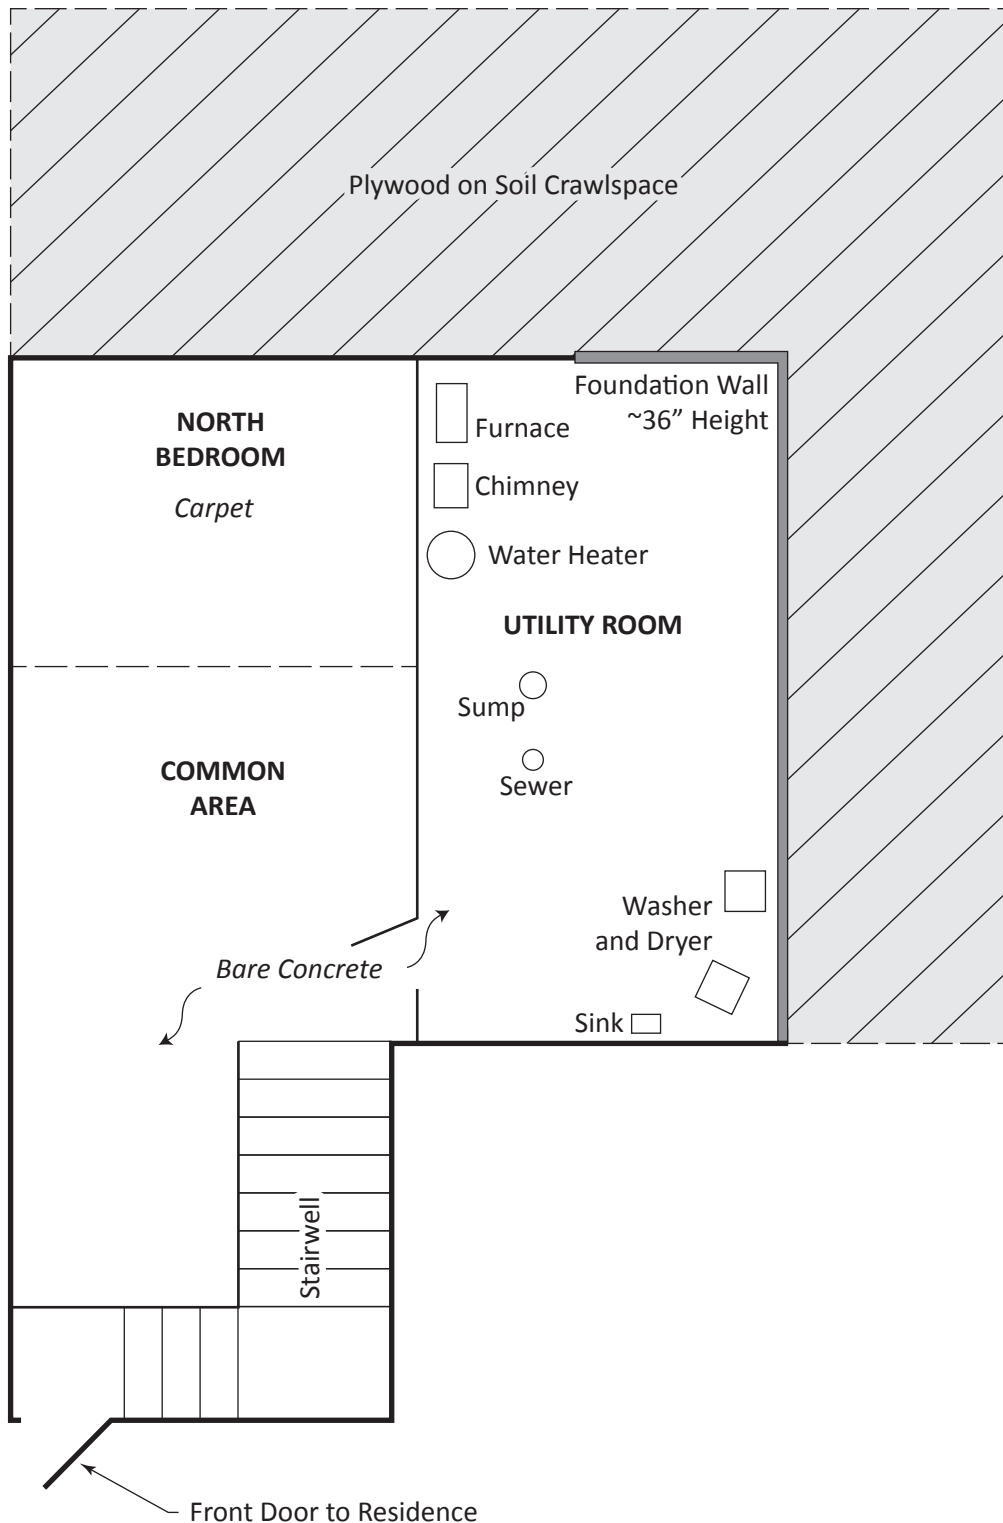
710 EAST 3RD STREET

Notes: Various structural posts and duct work within crawl space.
Forced air duct work.

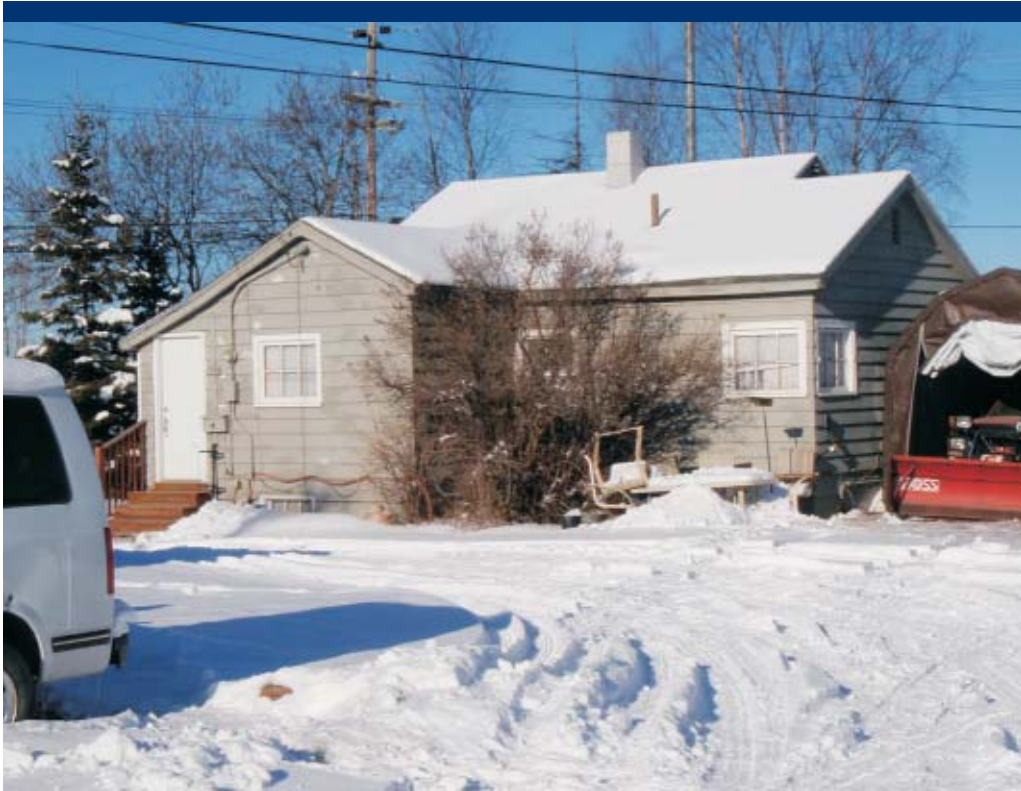
Photo 1 710 East 3rd Avenue (Residence).

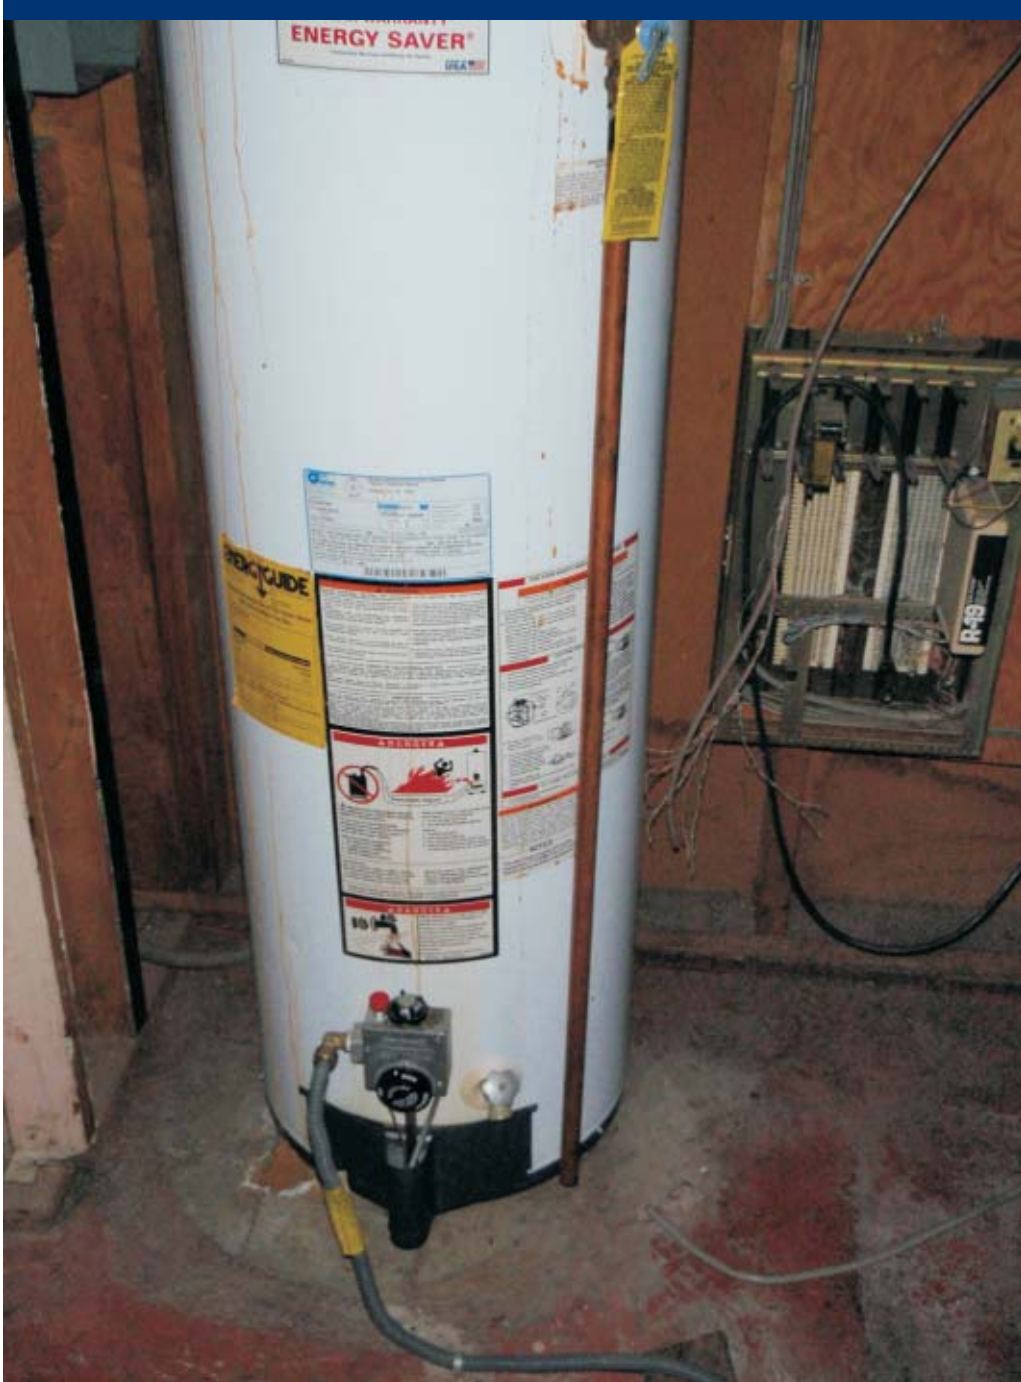
Photo 2 Water heater in utility room. Note derelict wiring to right.

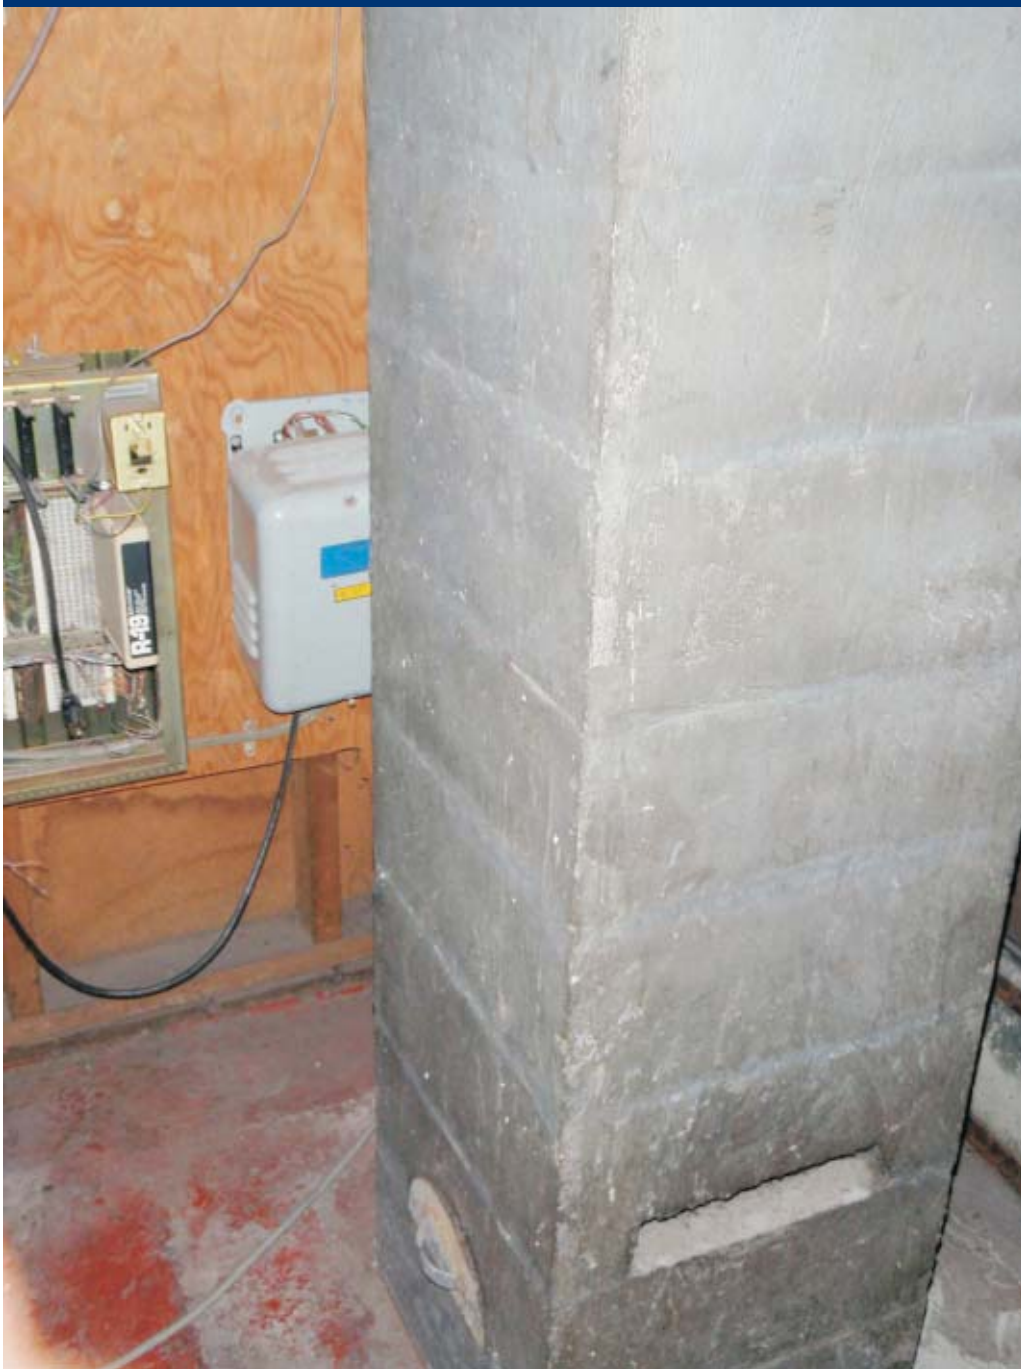
Photo 3 Chimney in utility room.

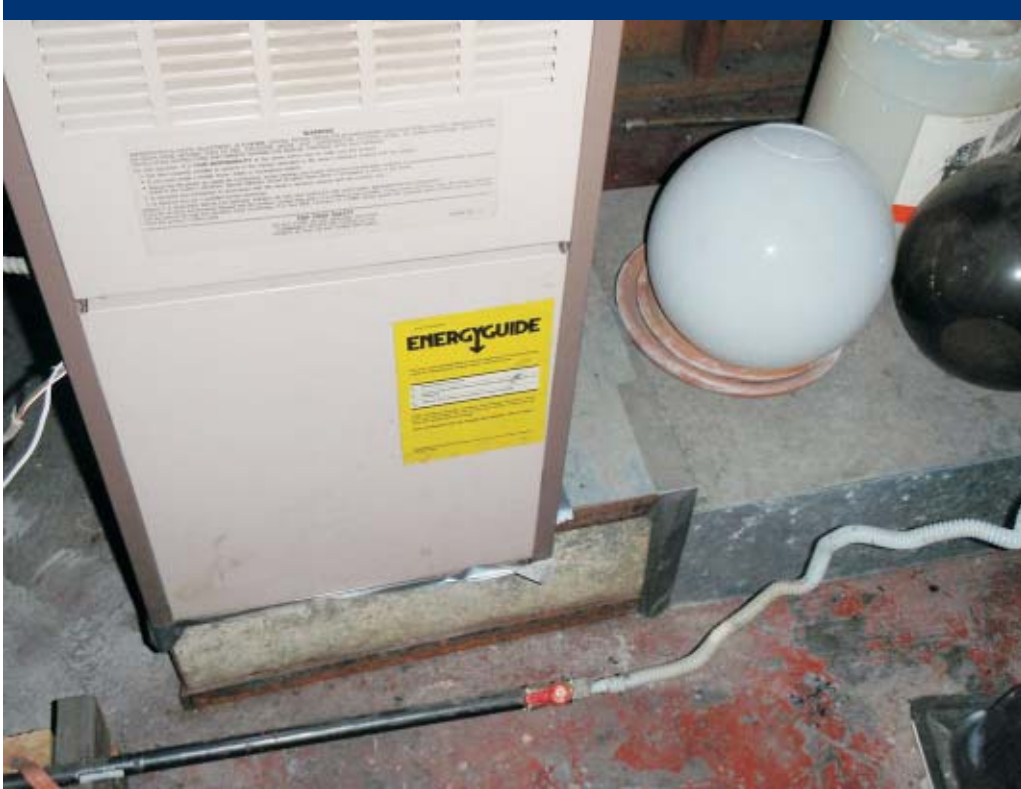
If yes, describe: Crawl space, electrical wiring, steel-to-plastic gas piping, and personal property storage.

Photo 4 Furnace in utility room. Note steel pipe-to-plastic gas line, and wiring to left.

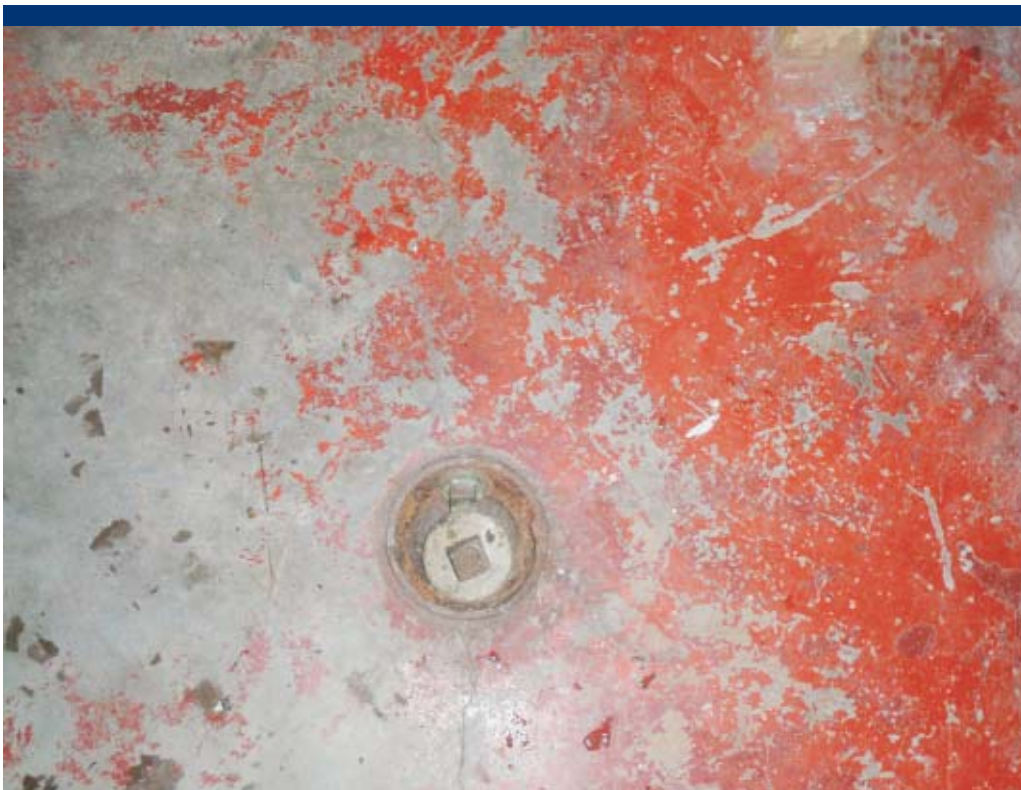
Photo 5 Plugged sump on utility room floor.

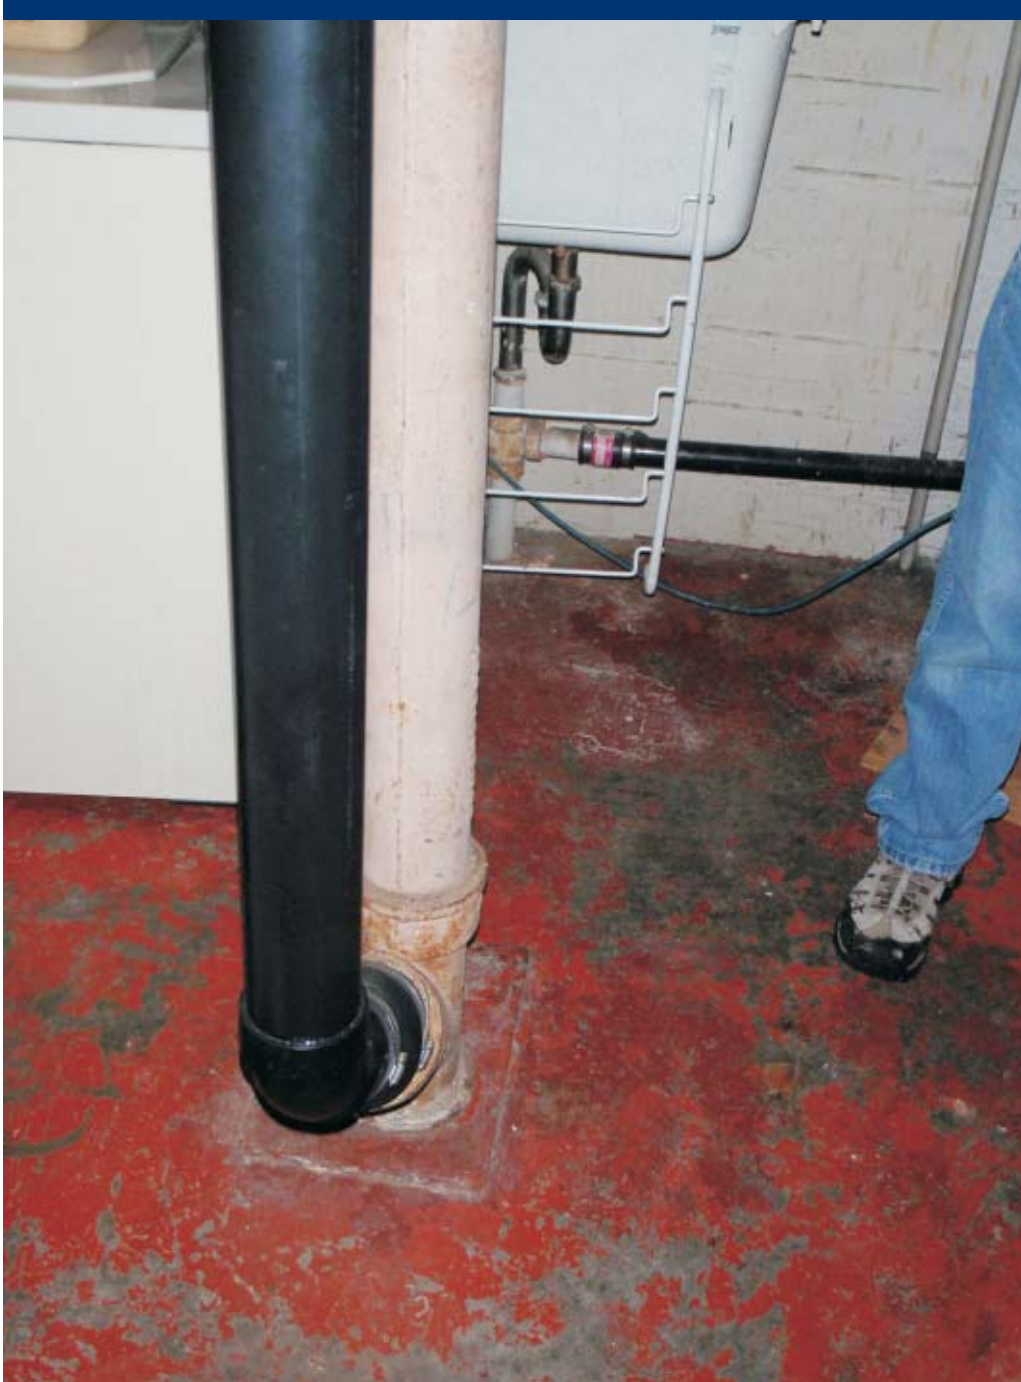
Photo 6 Sewer pipes to utility room floor.

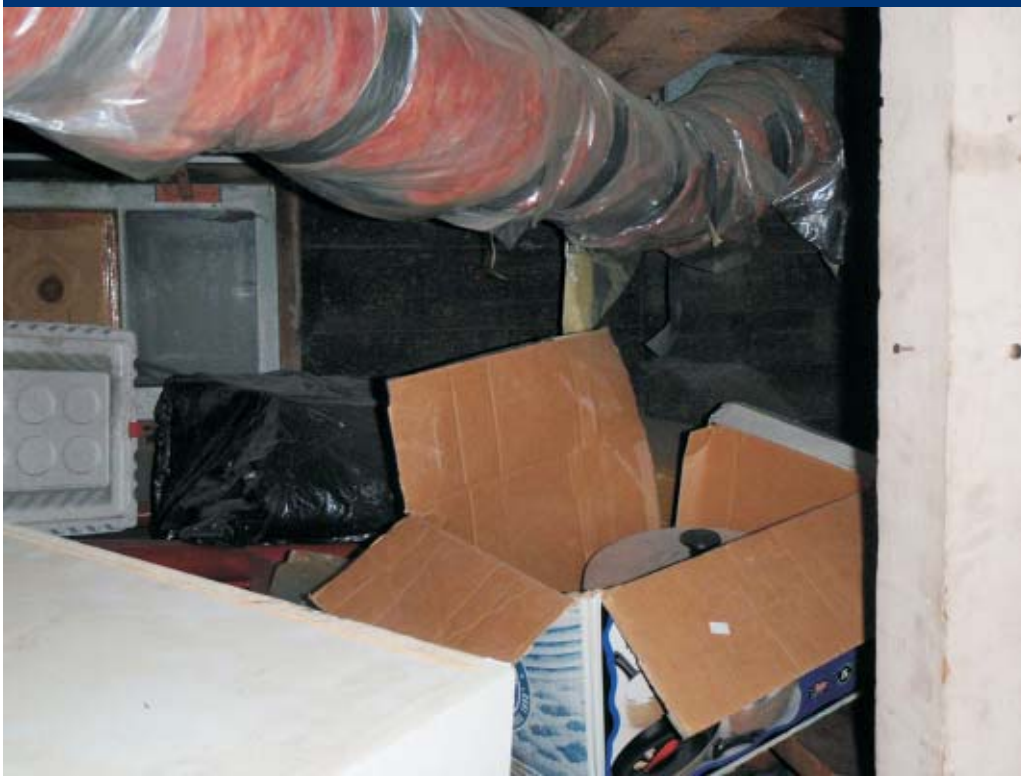
Photo 7 Forced air heating duct into crawl space.

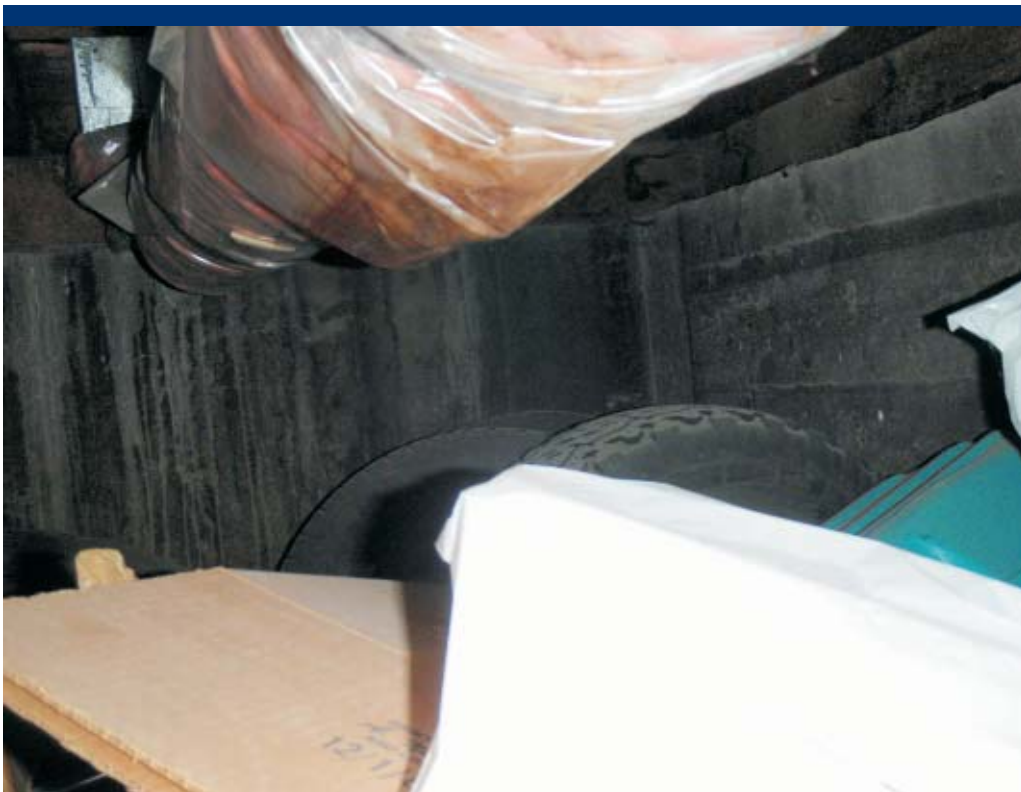
Photo 8 Forced air heating duct into crawl space.

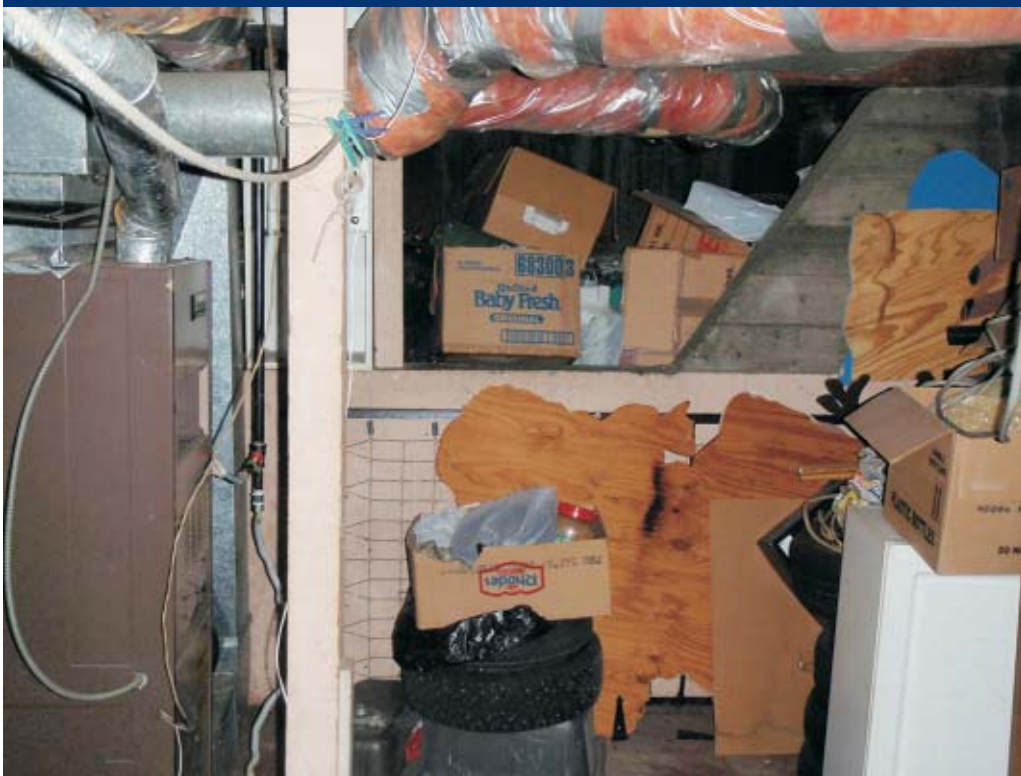
Photo 9 Storage in crawl space, furnace & heating ducts.

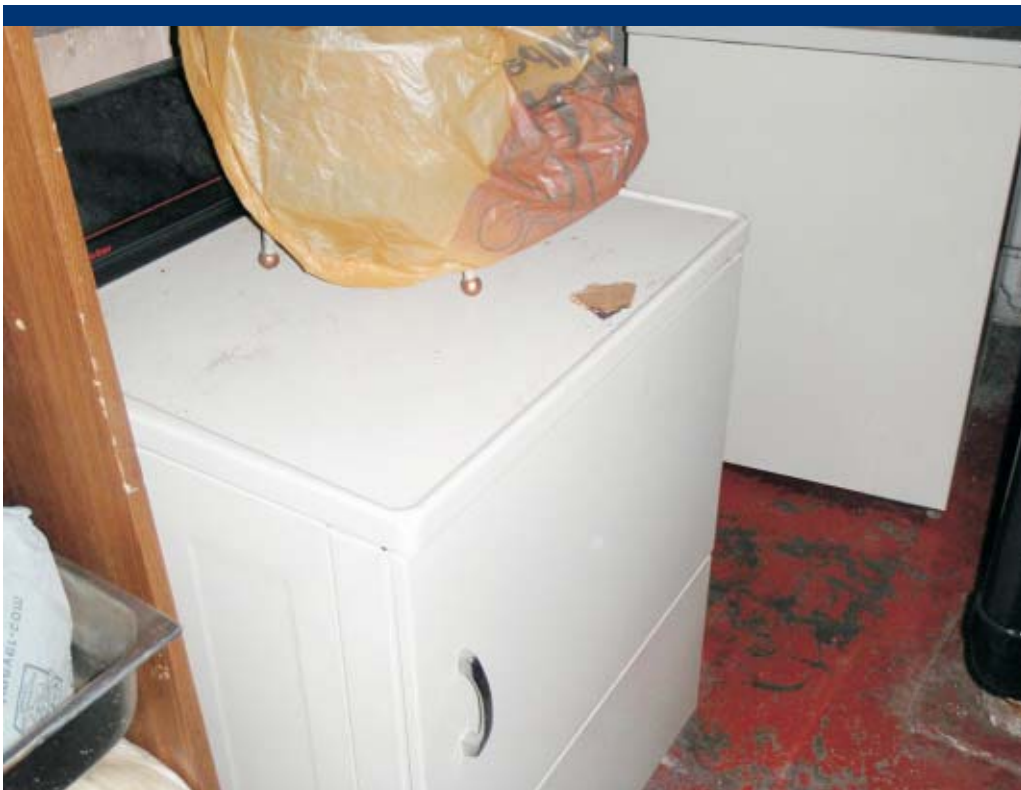
Photo 10 Washer and dryer in utility room.

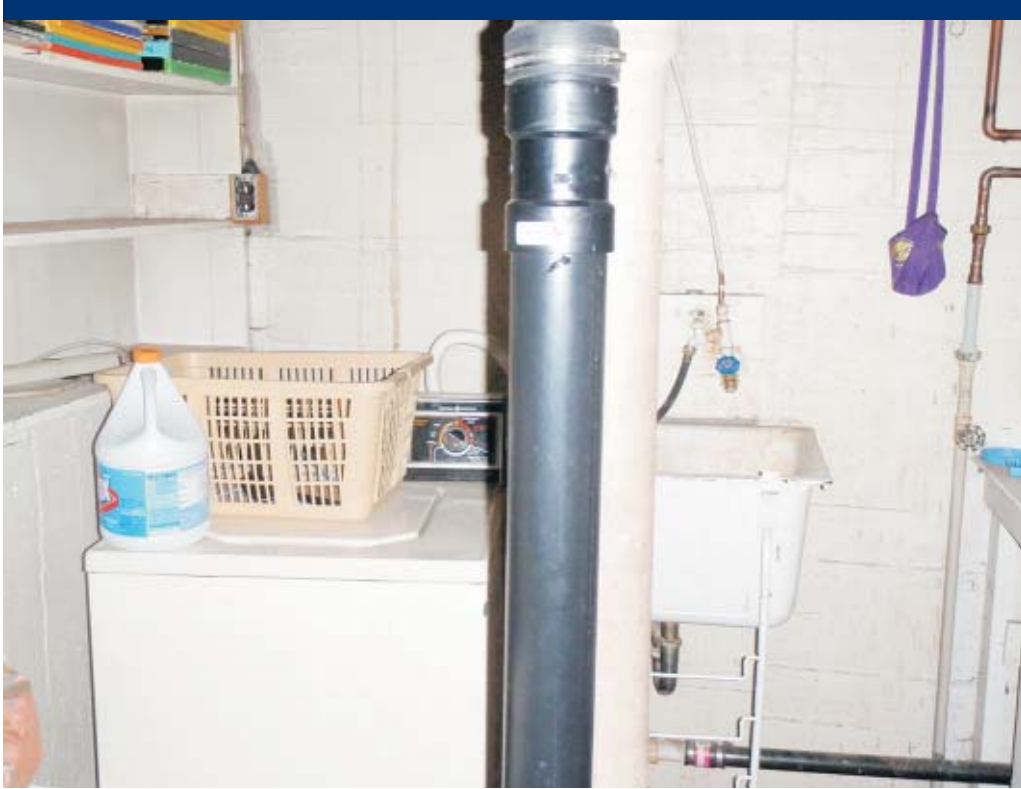
Photo 11 Sewer pipe, washer and sink in utility room.

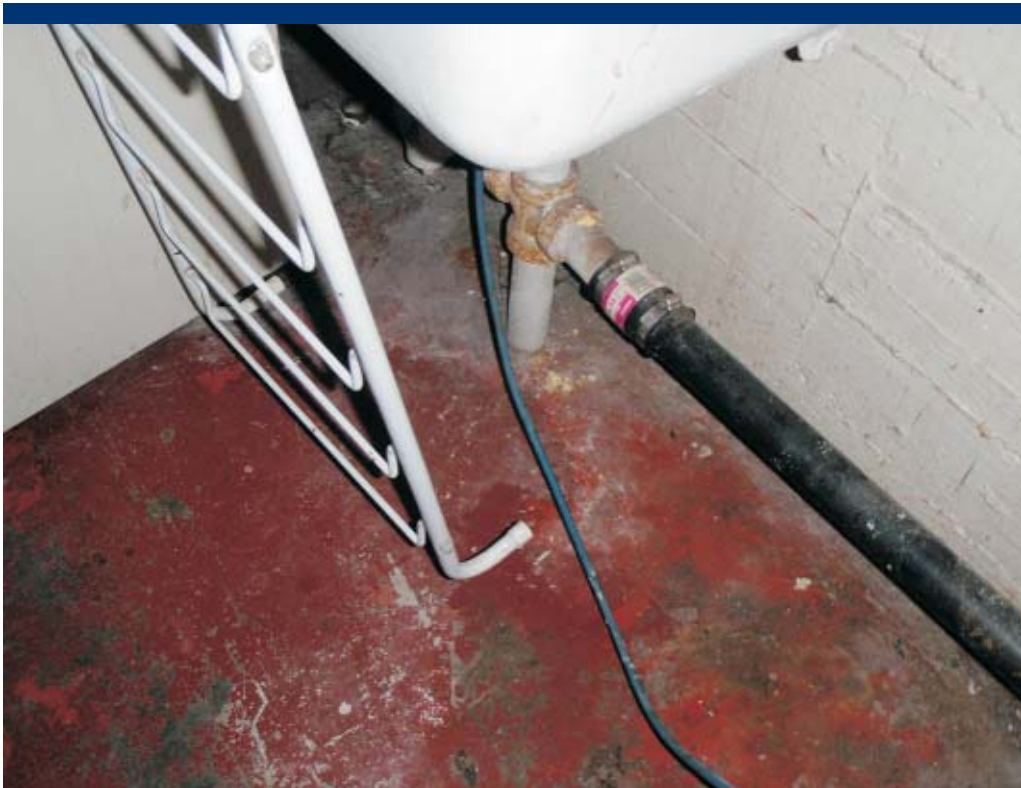
Photo 12 Sewer pipe beneath sink to utility room floor.

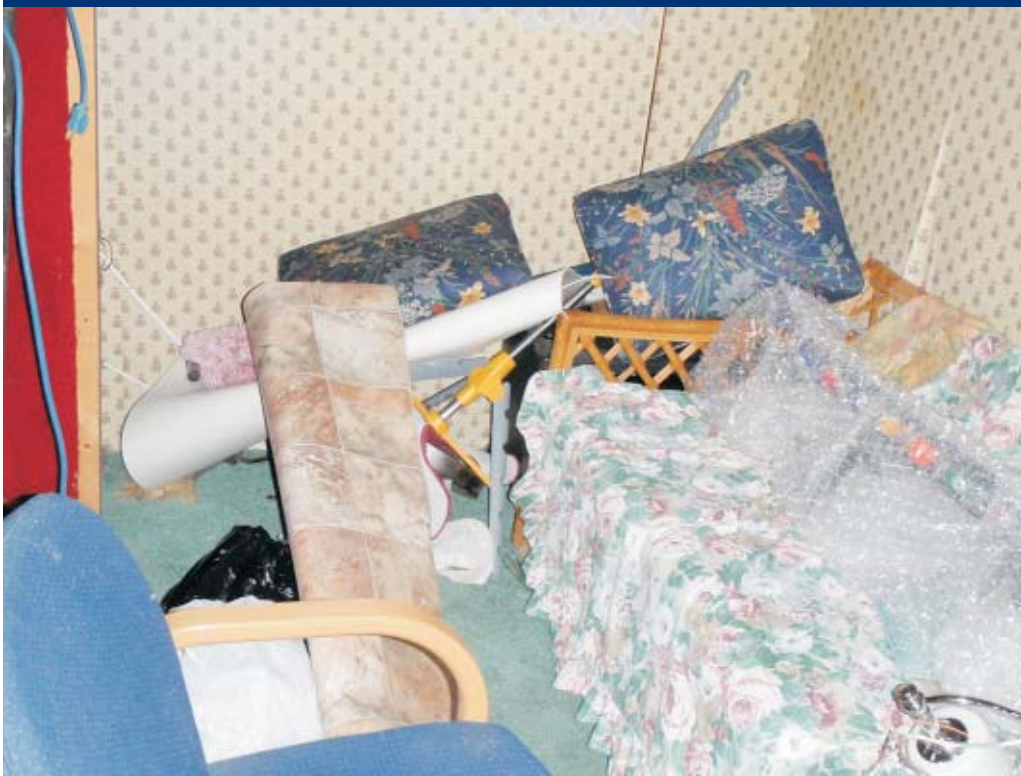
Photo 13 Southwest corner of common area.

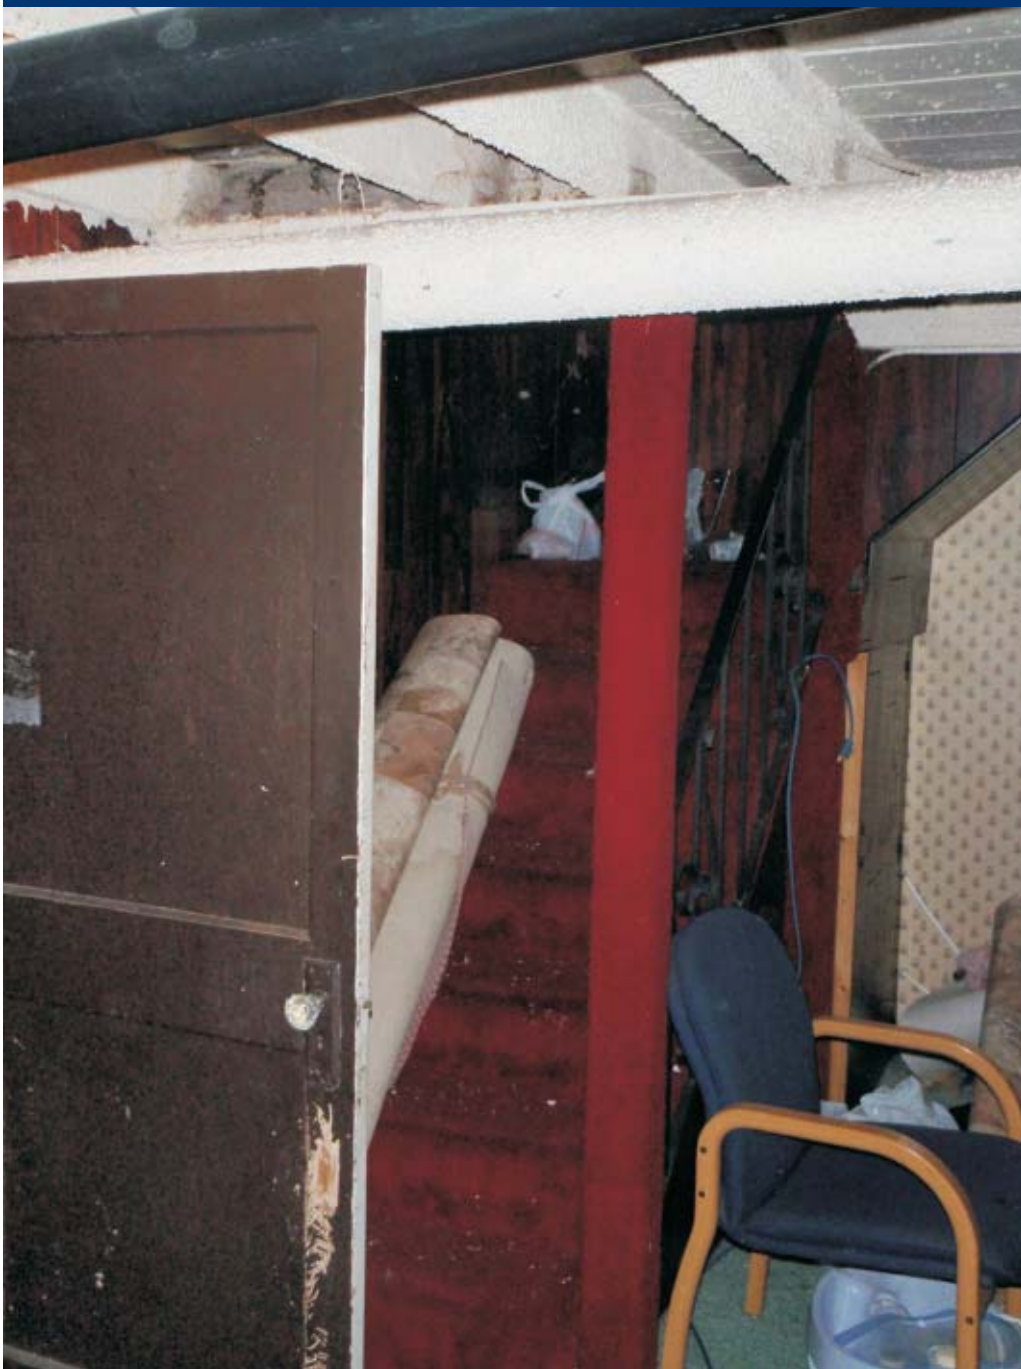
Photo 14 Stairwell and door to utility room.

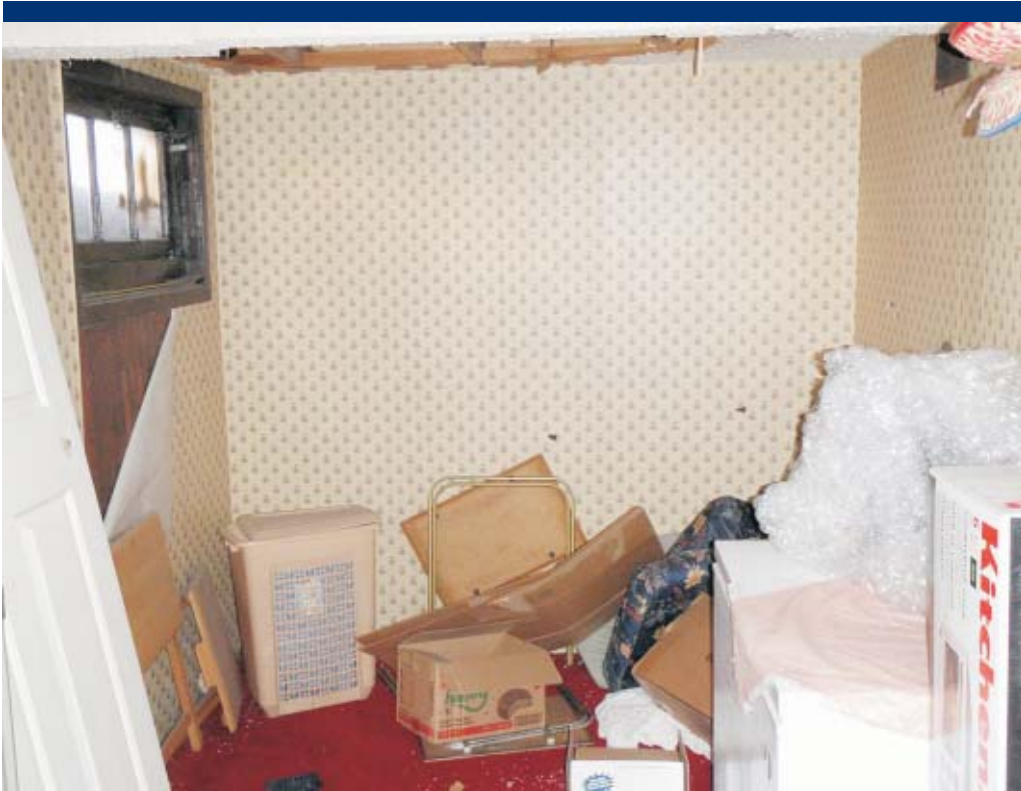
If yes, describe: Carpet in North Bedroom

Photo 15 North Bedroom.
